Deer Park Estate – 179 Tilburn Road, Deer Park

Growling Grass Frog Conservation Management Strategy (GGF CMS)

**Prepared for HB&B Property Pty Ltd,
and GPT Platform Pty Ltd**

May 2025
Report No. 22173.07 (1.7)

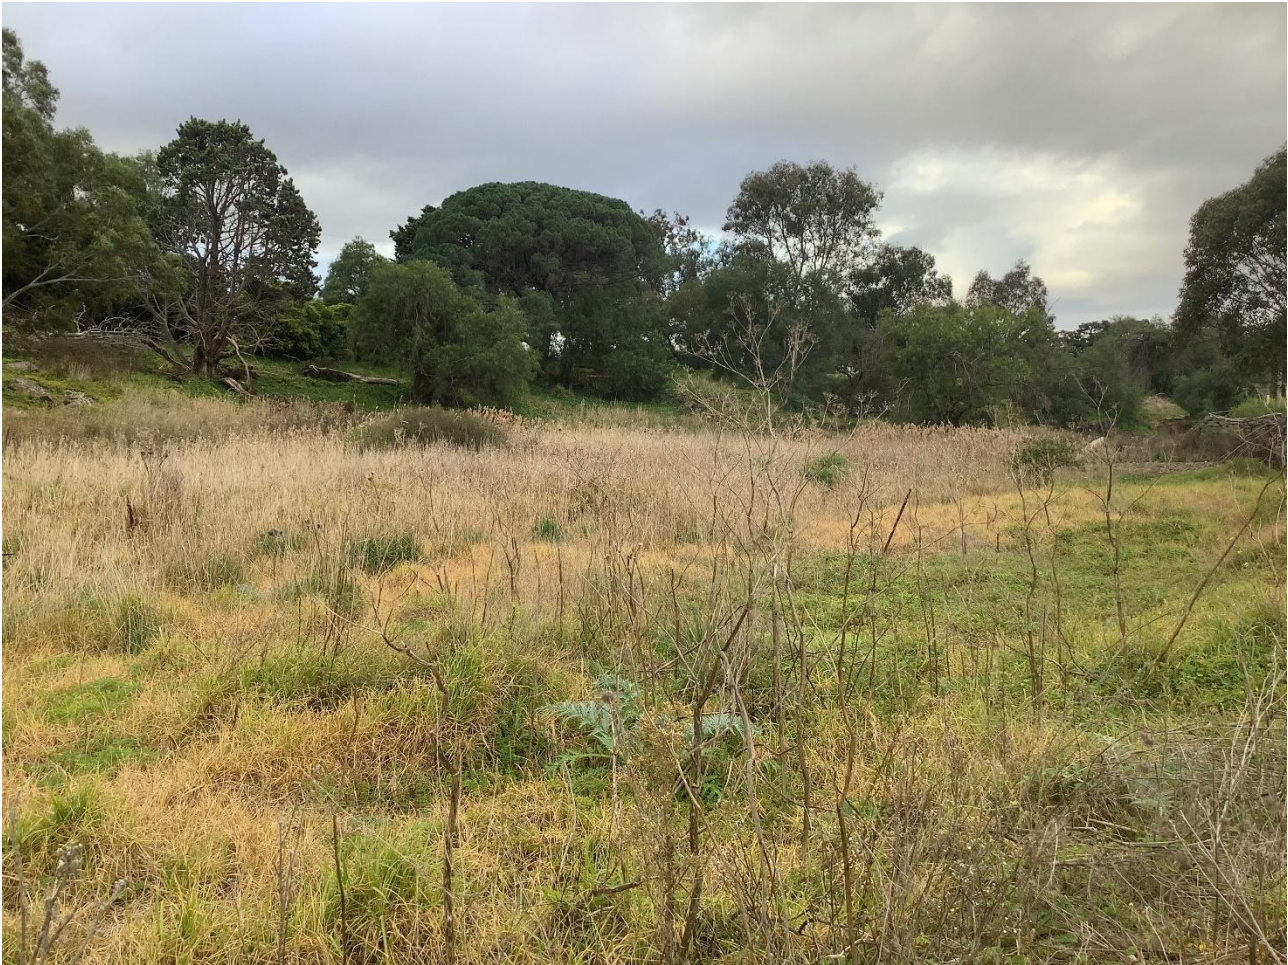
Photo 1: Representative area of Kororoit Creek showing weed invasion and planted trees with native vegetation on creek edge

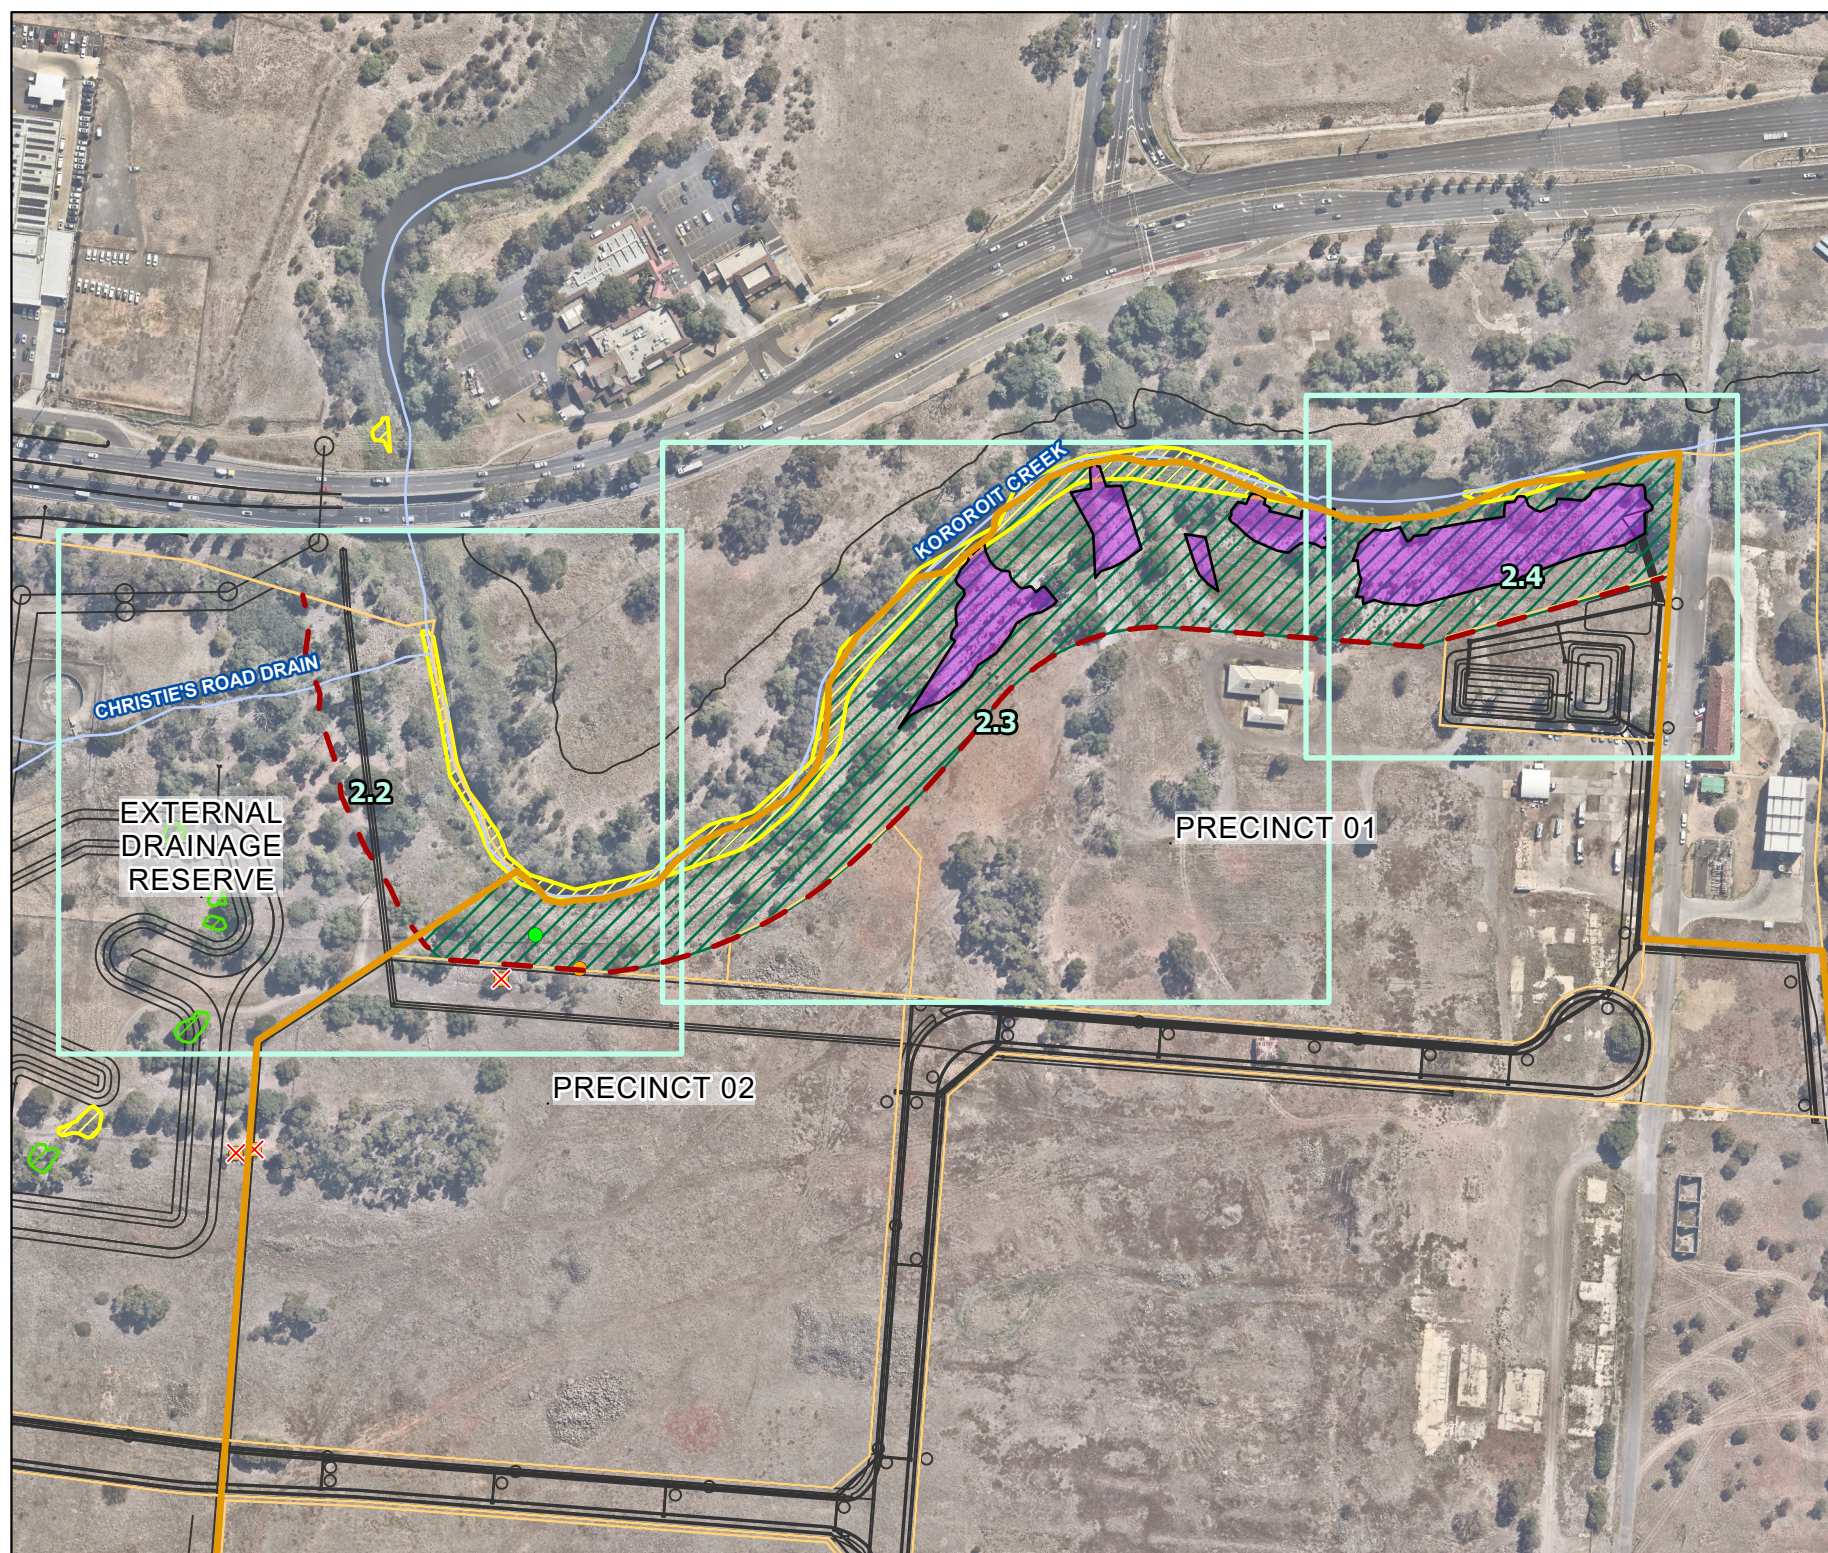
Figure 2.2: Proposed development - zoomed in on the buffer area

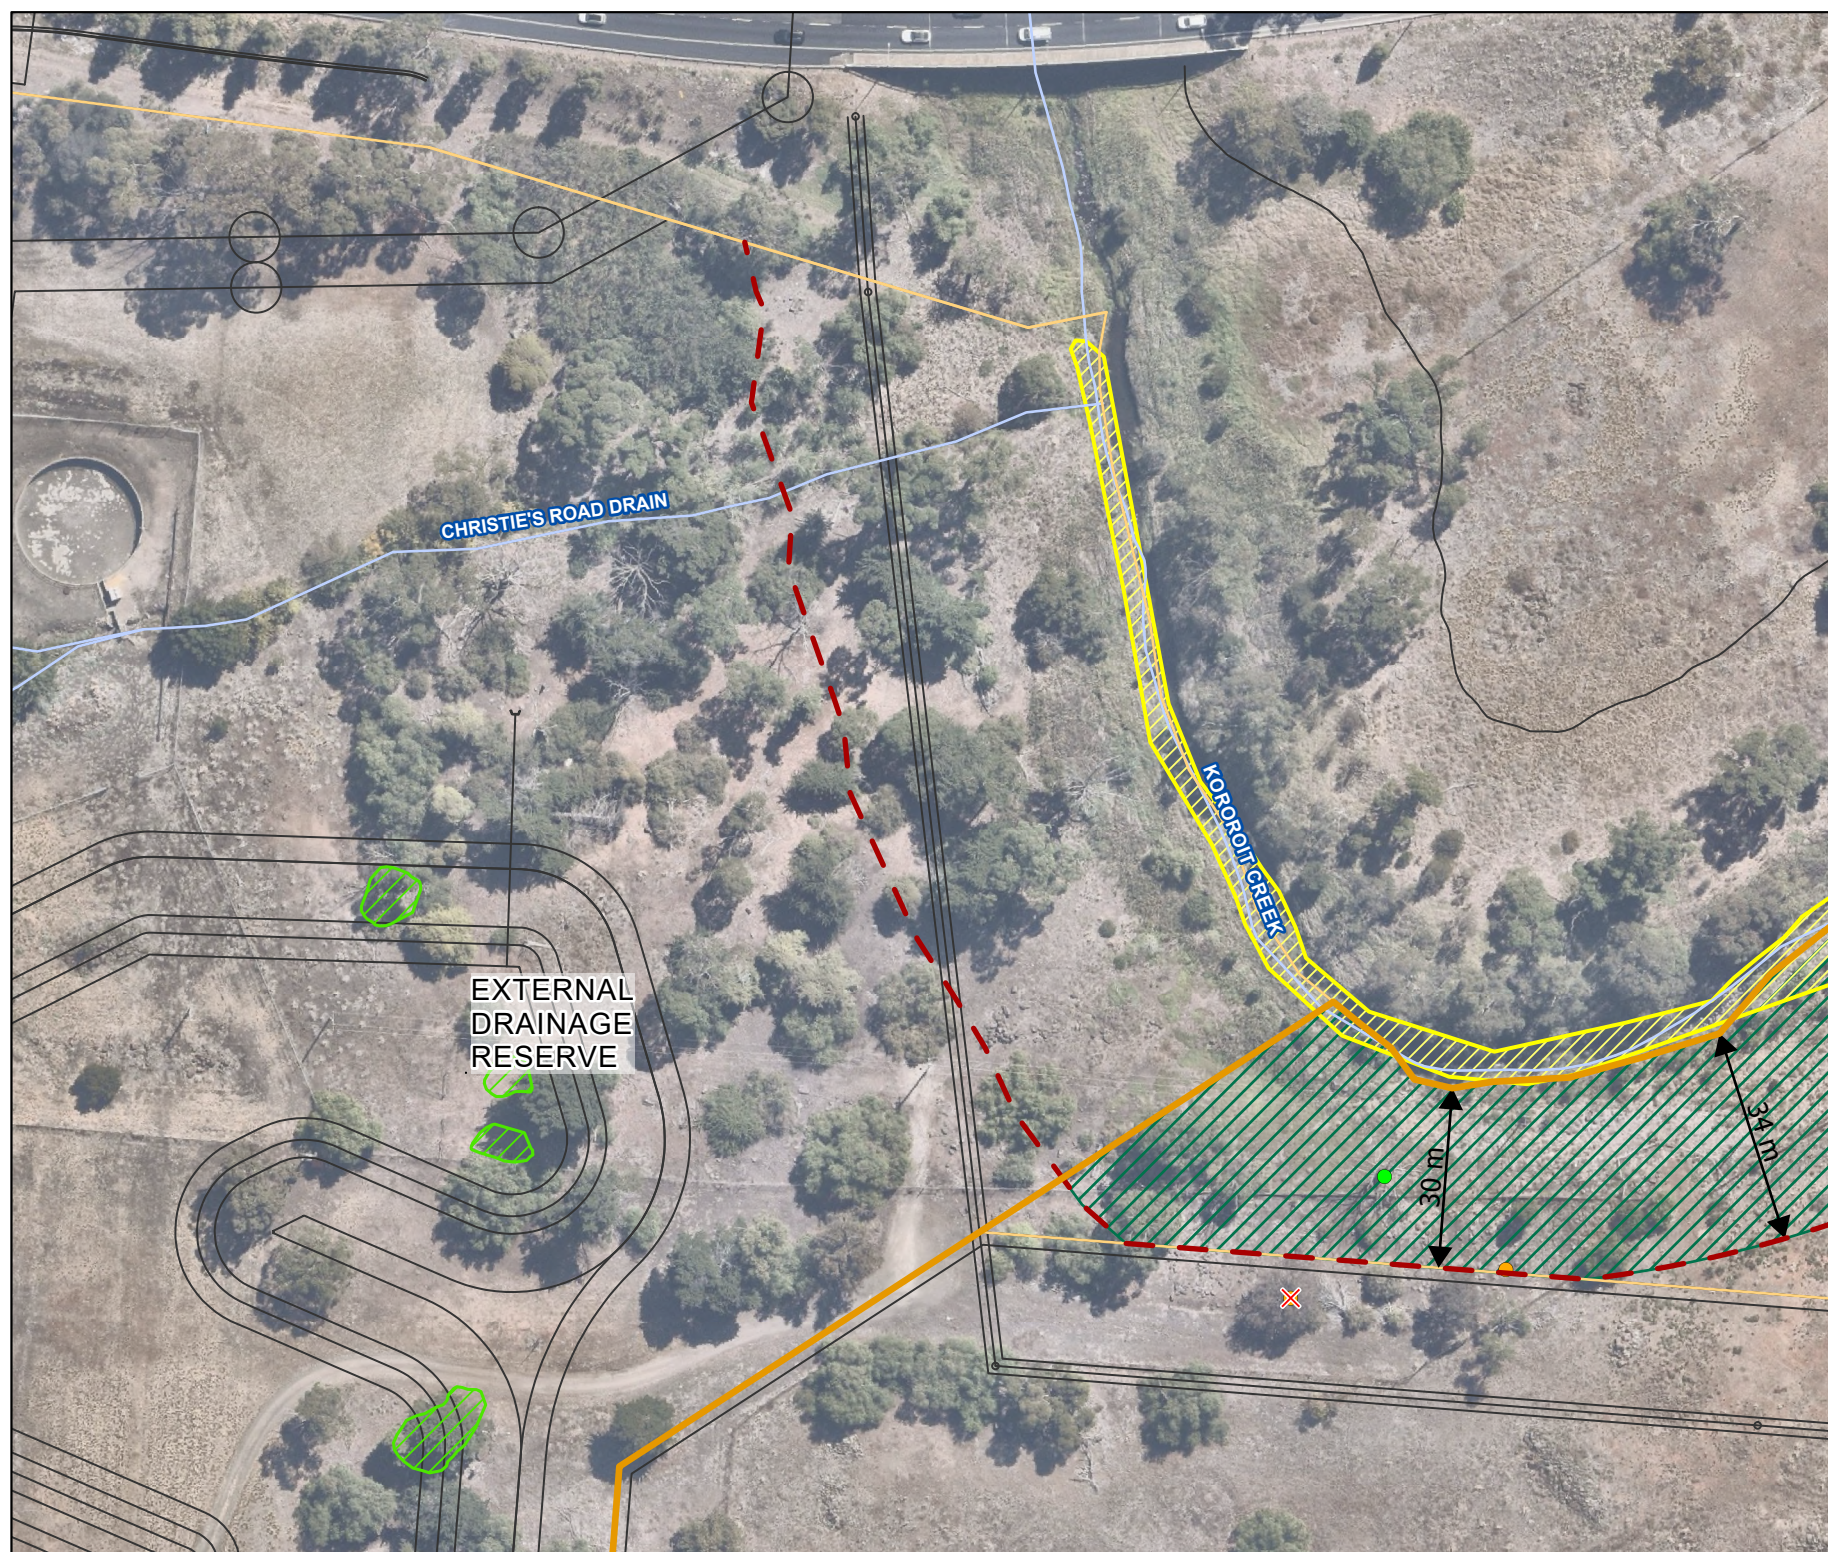
Figure 2.3: Proposed development zoomed in on the buffer area

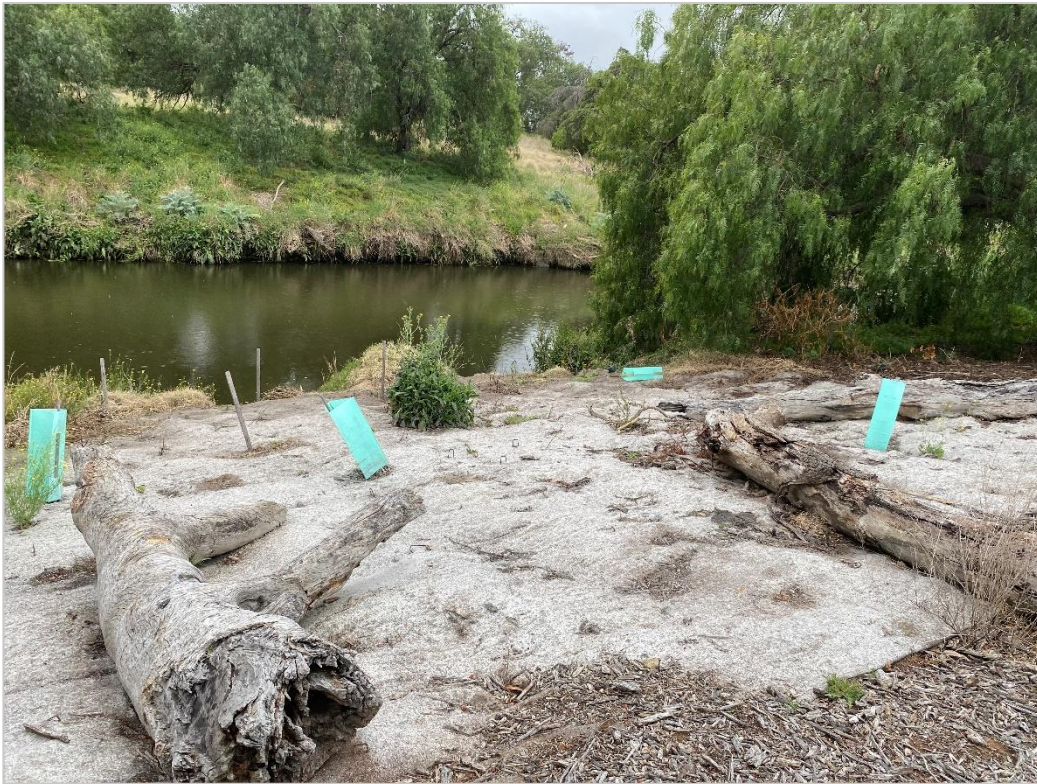
Photo 3: Kororoit Creek with revegetation works that have already occurred within the variable creek buffer zone visible in the foreground. This deep section of Kororoit Creek lacks preferred habitat features such as rocks and floating and submergent vegetation.

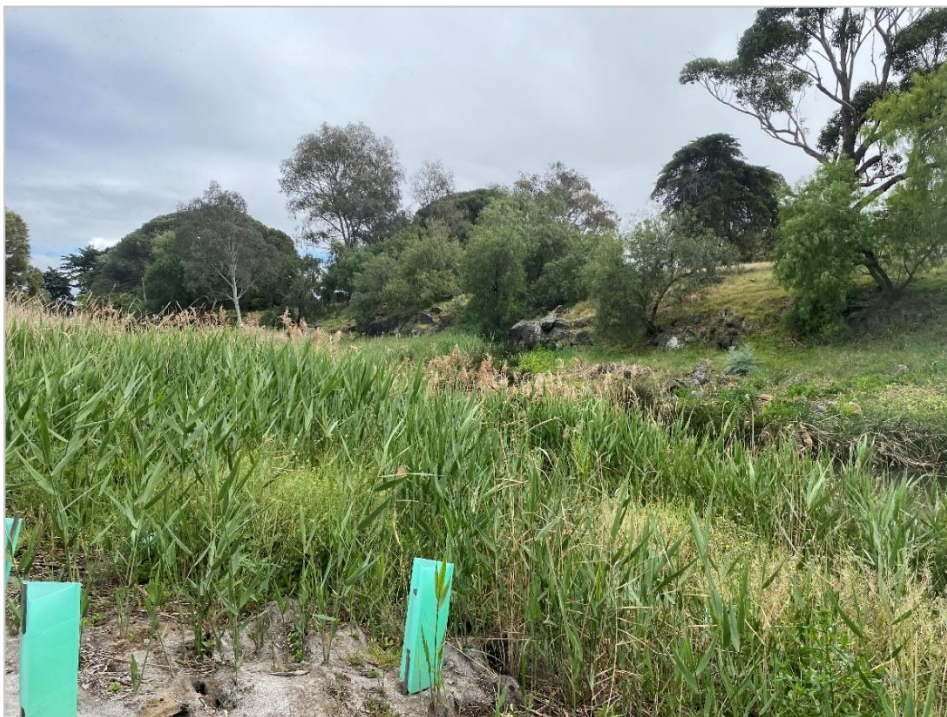
Photo 4: This section of Kororoit Creek is dominated by Common Reed and lacks preferred habitat such as rocks and floating and submergent vegetation. Some revegetation works that have already occurred can also be seen in the foreground.

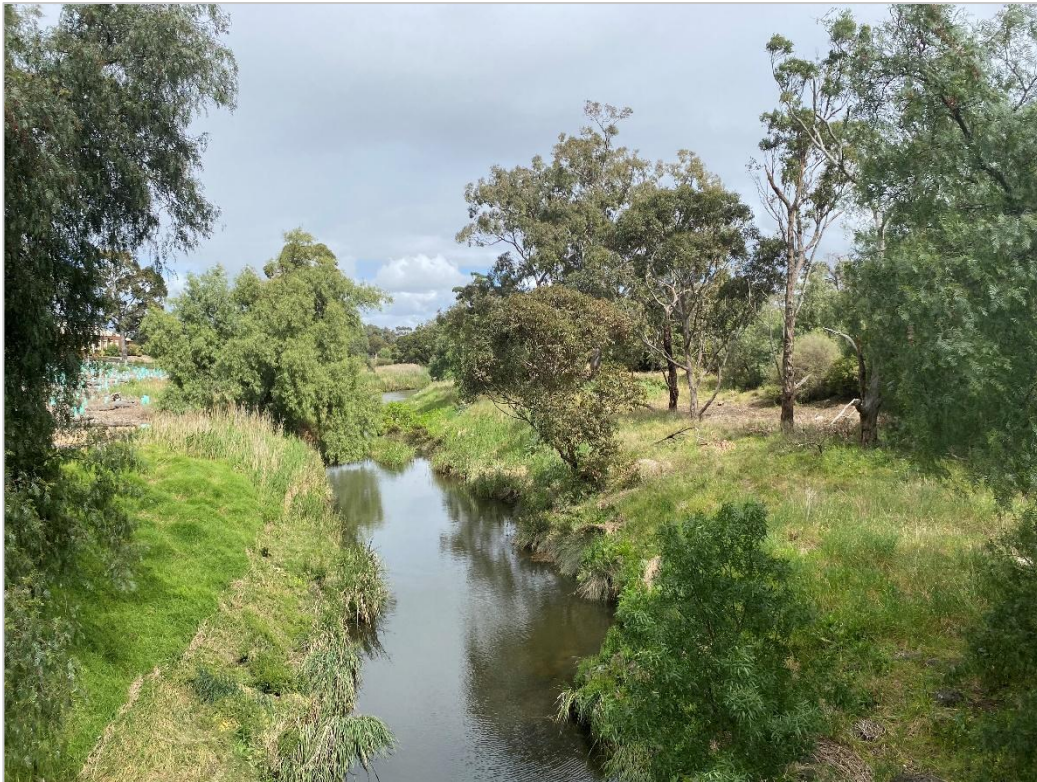
Photo 5: Kororoit Creek (facing west) with the proposed stormwater outfall from drainage reserve 3 to occur in the area along the southern (left) bank. Revegetation works that have already occurred southern bank can also be seen and are shown closer up in Photo 3 and 4.

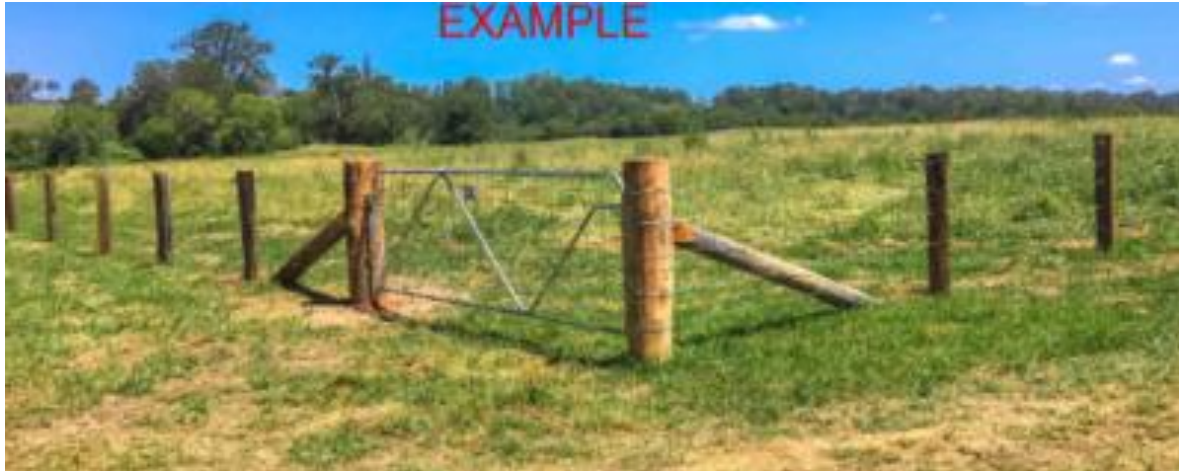
Photo 5: Example of the permanent fencing proposed for the variable Buffer zone along Kororoit Creek.

The proposed development includes the erection of a permanent rural style fencing with gates along the length of the variable buffer zone along the Kororoit Creek. This fencing will delineate the conservation area to protect the creek buffer area from access by people unnecessarily. Signage must explain the purpose and importance of the GGF buffer. This fencing design is in accordance with Western Sydney Parklands Design Manual 2020 (See example photo 5 below).

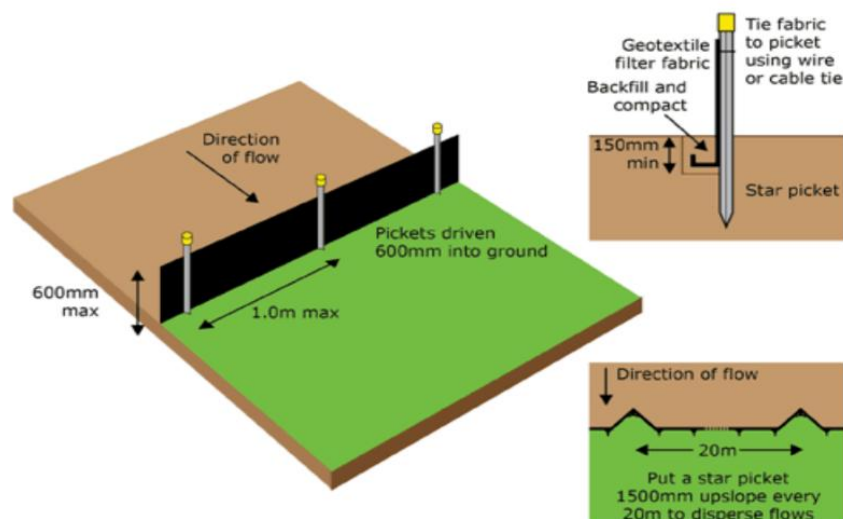
Figure 4: EPA guidelines for sediment fencing construction

- All earthworks must be undertaken in a manner that will minimise soil erosion and adhere to Construction Techniques for Sediment Pollution Control (EPA 1991).
- Water runoff from the construction site must be diverted to avoid the runoff from entering the drainage line. Sediment fencing must be installed to minimise the potential impact of water runoff into the waterway. EPA construction guidelines are provided below in Figure 4 and Figure 5 (EPA 2004).

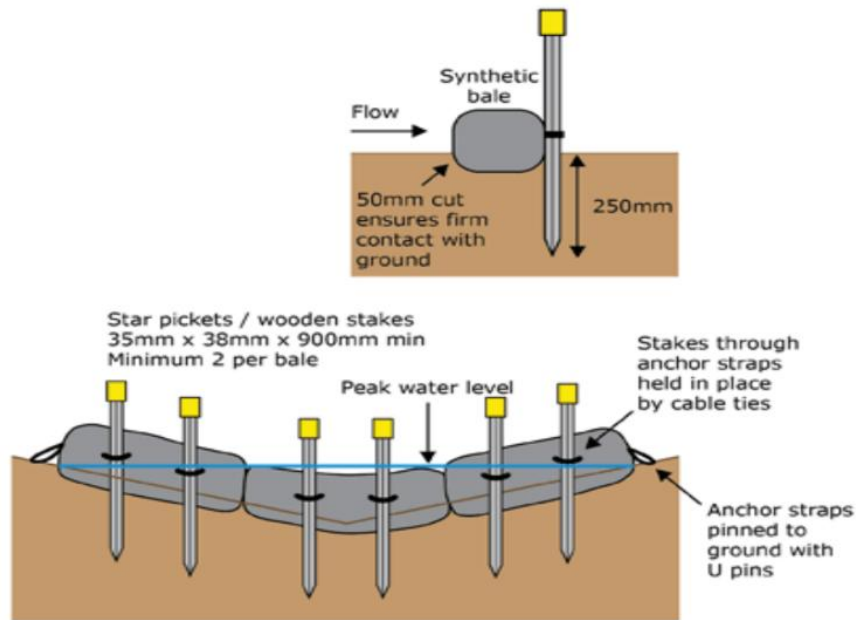
Figure 5: EPA guidelines for synthetic bale sediment control construction

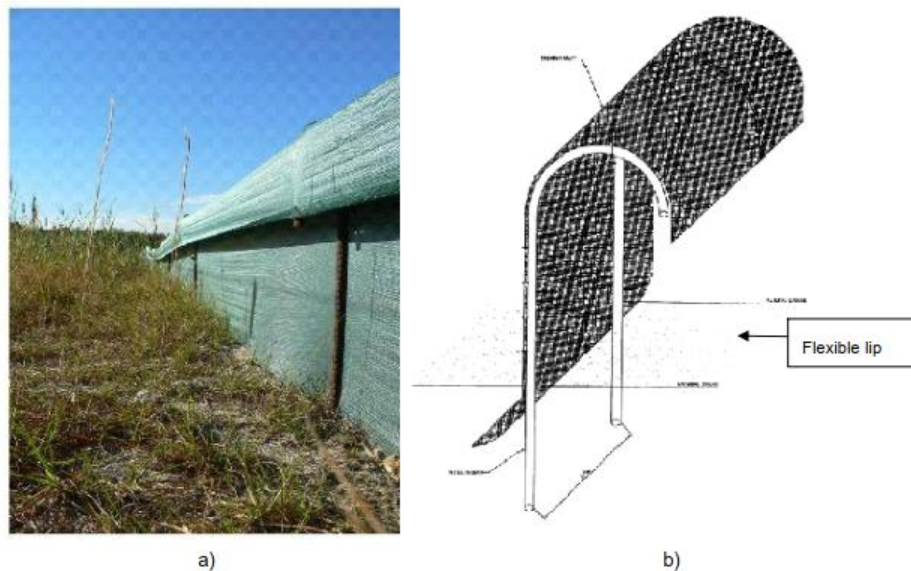
Figure 6: Temporary Frog Proof Fencing design (Department of Transport and Main Roads, 2024).

Suitable GGF exclusion fencing is shown in Figure 6 and Figure 7 below.

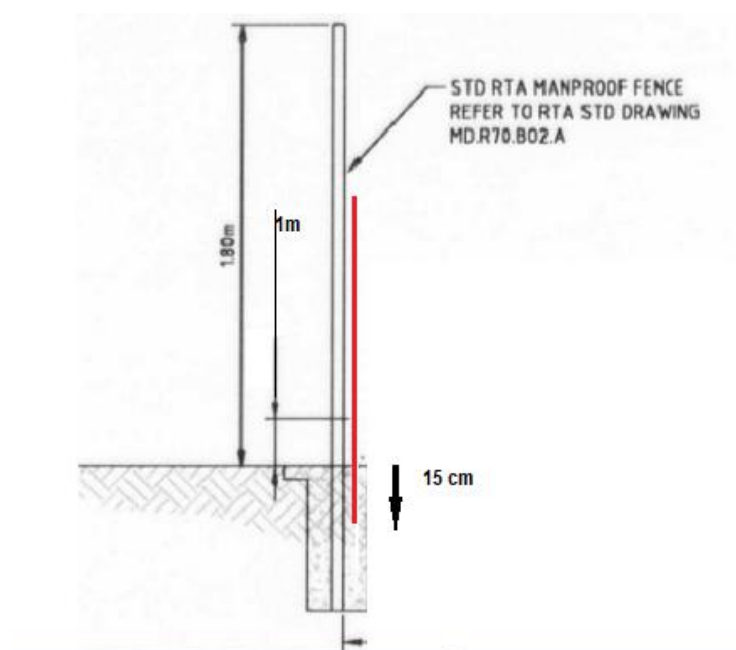
Figure 7: Temporary frog proof fencing attached to existing fence design.

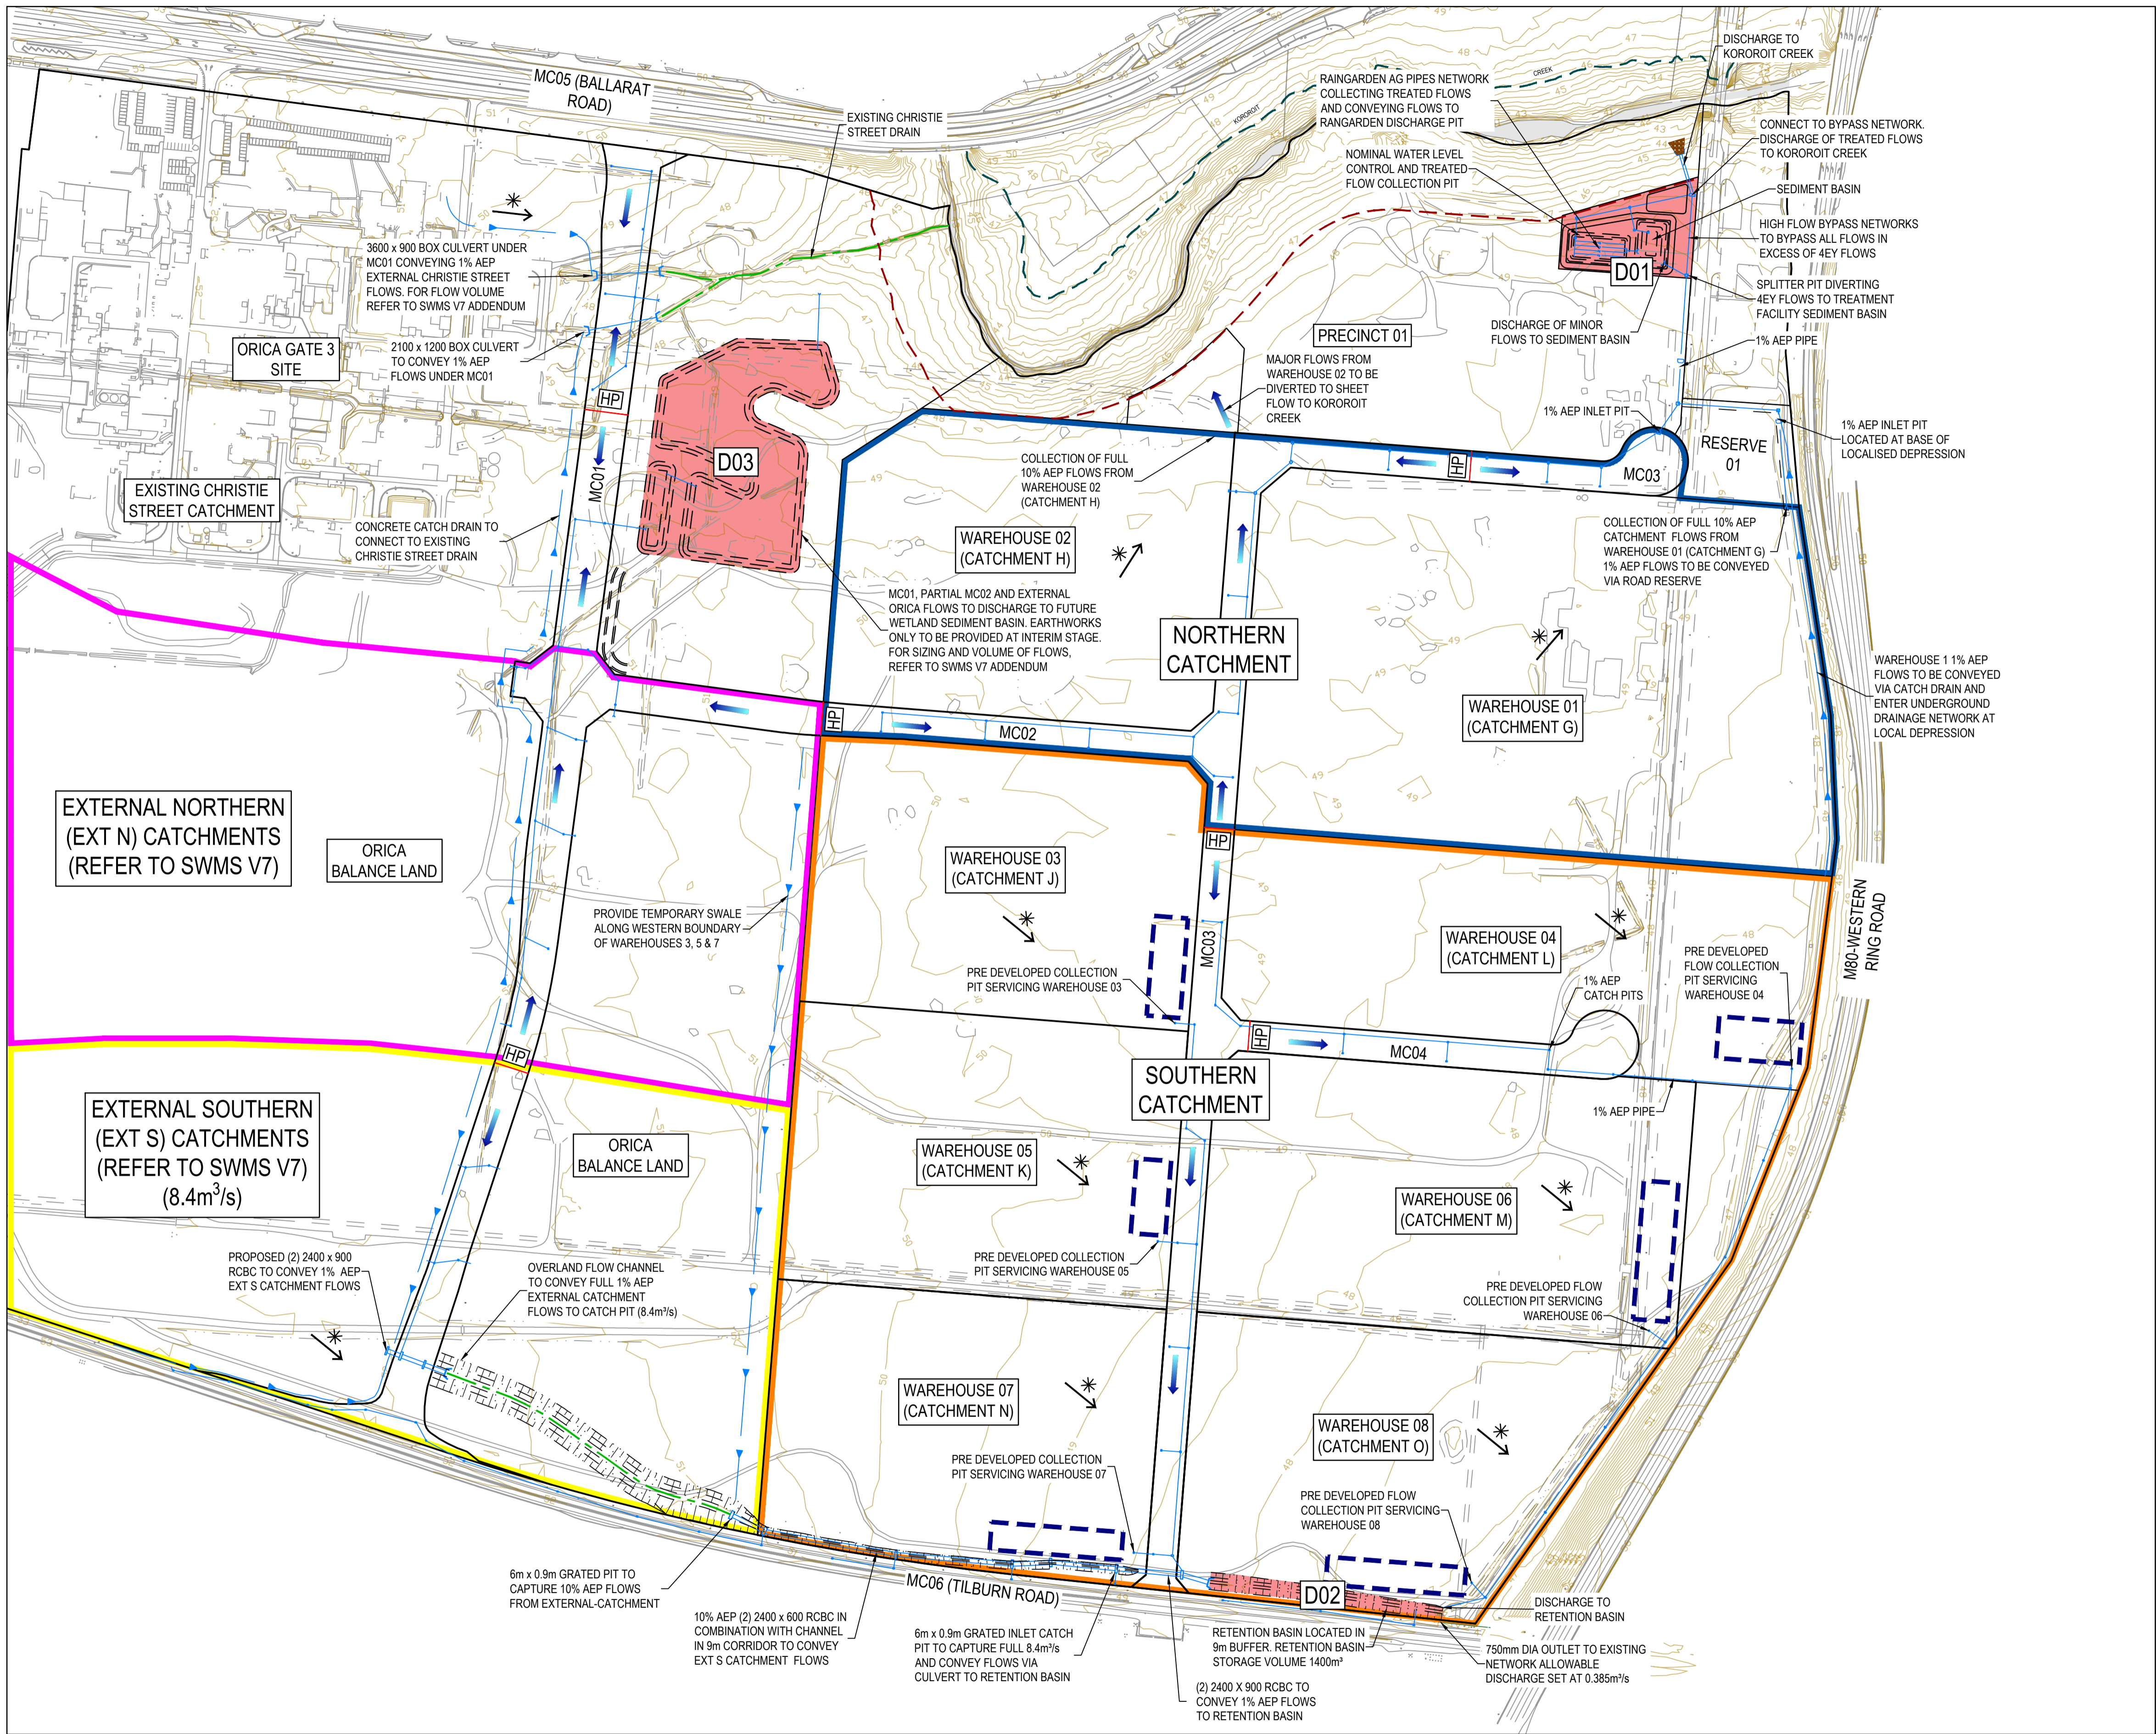
MELWAYS REF	PROJECT / DRAWING No	SHEET No	REVISION
25 H10	3508E-MP-ID-401	01 of 05	A

Deer Park Estate
Brimbank City Council
Masterplanning & Information Documents
Drainage Masterplanning
Overall Drainage Scheme

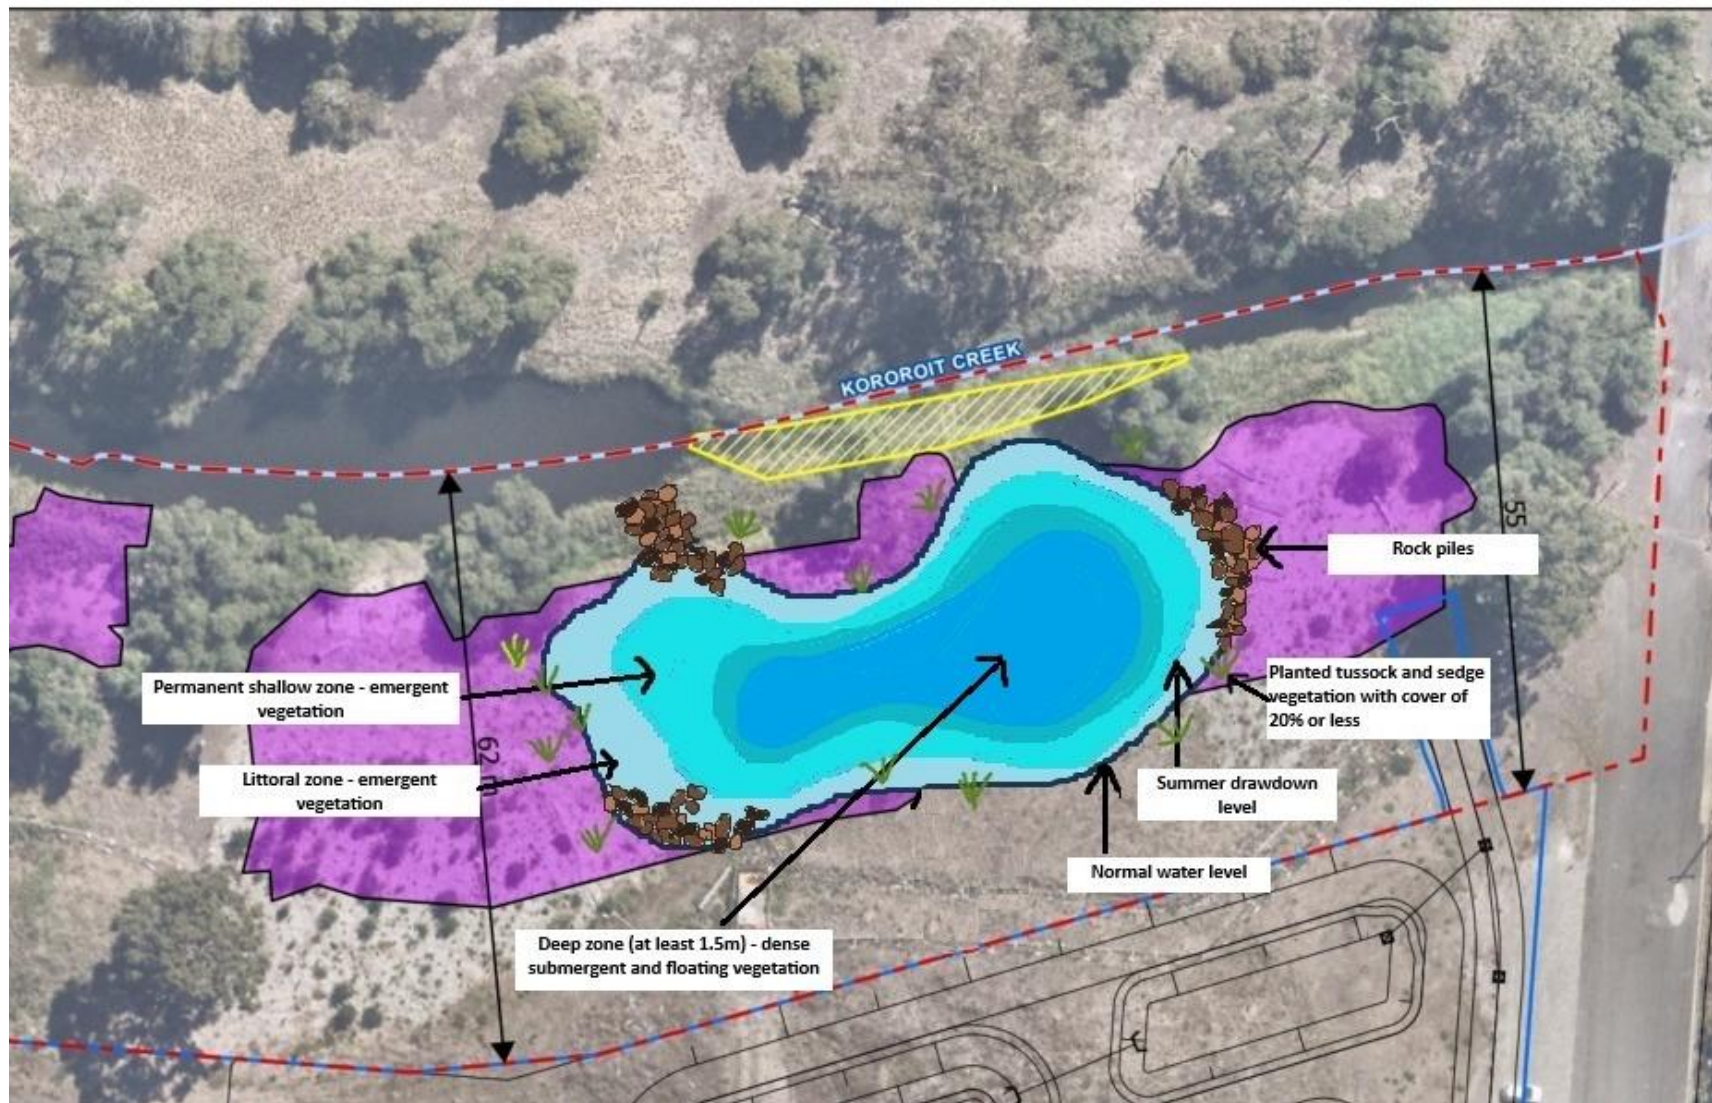
Appendix 5 Indicative GGF habitat design for the buffer area

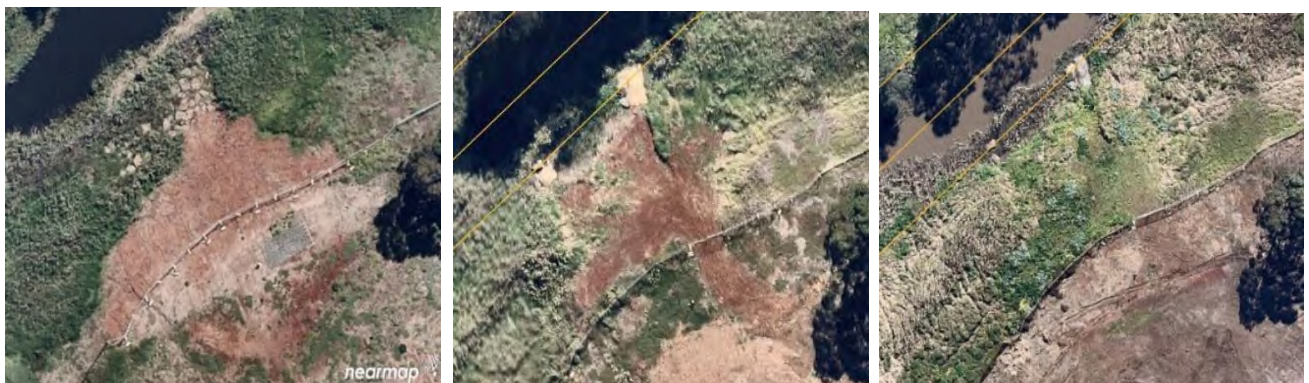
Figure 3-1, Backfilled surface of Area 1 from Nearmap aerial images (left to right – 17 February 2020, 17 April 2022 and 14 December 2022)

Figures A-1(A) and A-1(B) in **Appendix A** provides a plan view of the areas where excavation has been completed. The excavations have been backfilled with local basaltic rock and soil. As discussed with Gerard Morel (Waterways and Land Officer, Werribee Catchment, Melbourne Water) on 9 May 2021, mulch has been placed in most of Area 3 and 'coarse woody debris' (log and dead trees) have been placed in Areas 2 and 3. Aerial images are provided below (**Figures 3-1, 3-2, 3-3 and 3-4**), showing the state of backfilled excavations at various times on 'Nearmap' images.

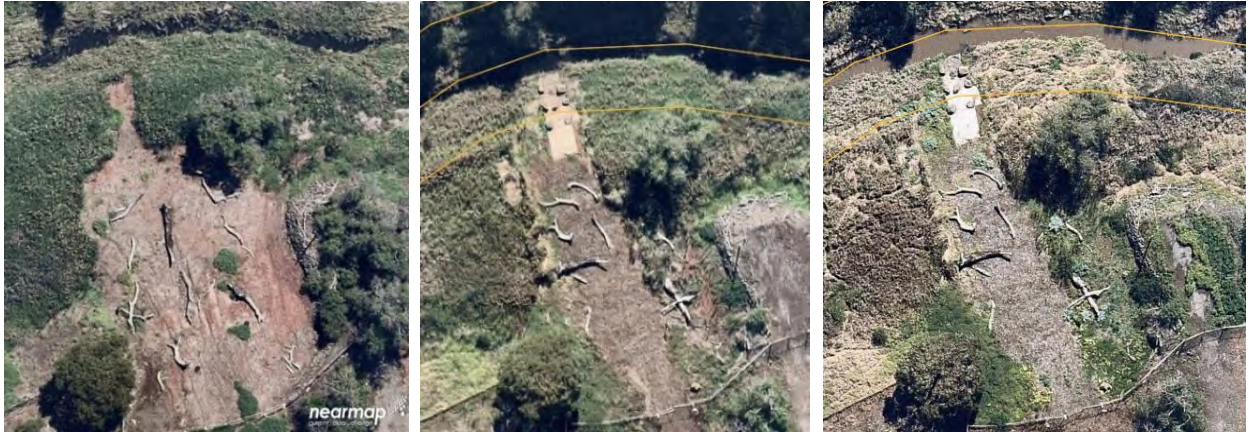
Figure 3-2, Backfilled surface of Area 2 from Nearmap aerial images (left to right – 17 February 2020, 17 April 2022 and 14 December 2022)

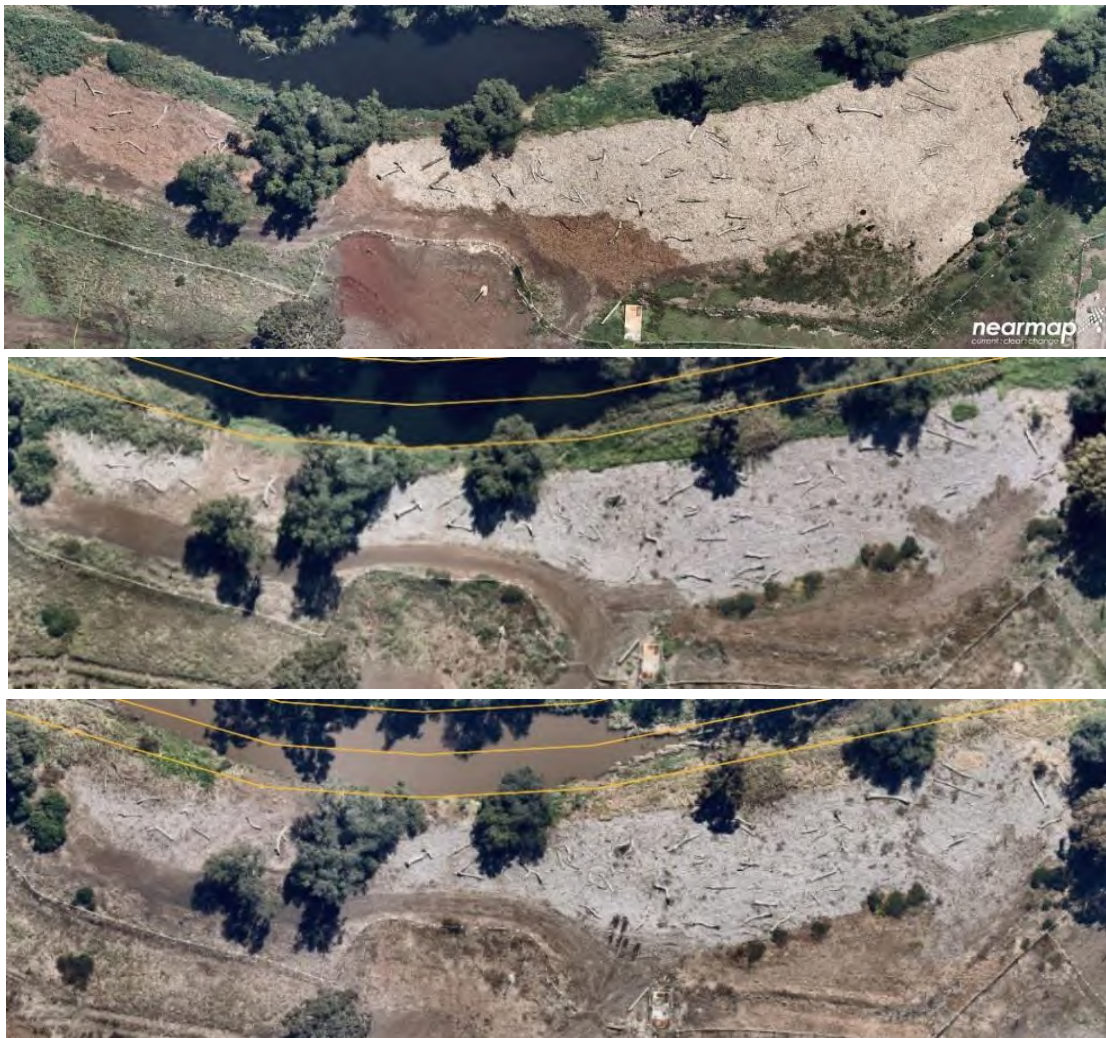
Figure 3-3, Backfilled surface of Area 3 from Nearmap aerial images (top to bottom – 17 February 2020, 17 April 2022 and 14 December 2022)

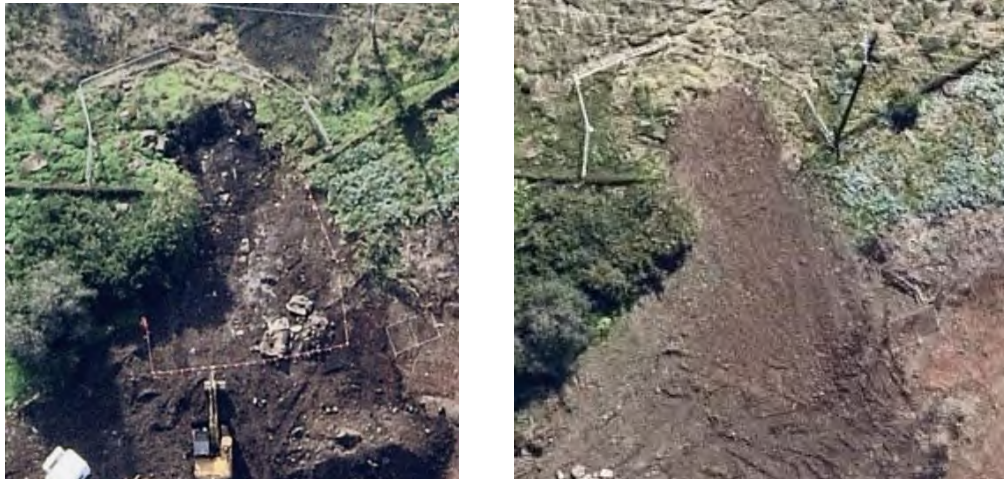
Figure 3-4, Backfilled surface of Area 8 showing soil cover (Nearmap 28 June 2022 on the left, 14 September 2022 on the right)

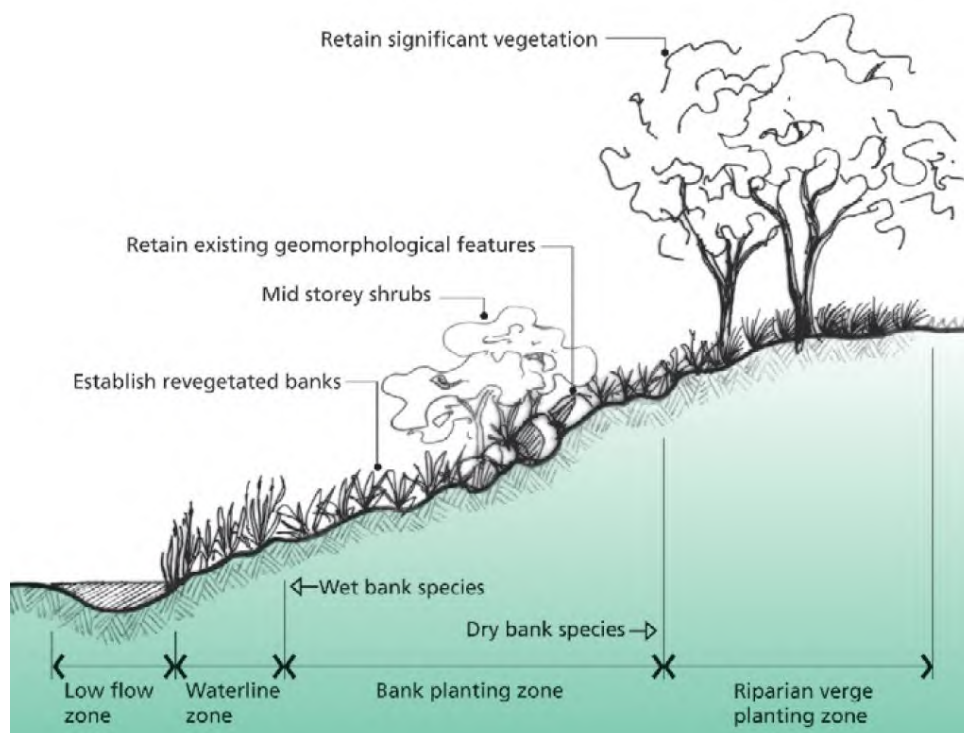
Figure 4-1 - Cross-section showing planting zones according to moisture gradient along the creek bank and verge.
