Deer Park Estate – 179 Tilburn Road, Deer Park

Growling Grass Frog Conservation Management Strategy (GGF CMS)

**Prepared for HB&B Property Pty Ltd,
and GPT Platform Pty Ltd**

May 2025
Report No. 22173.07 (1.7)

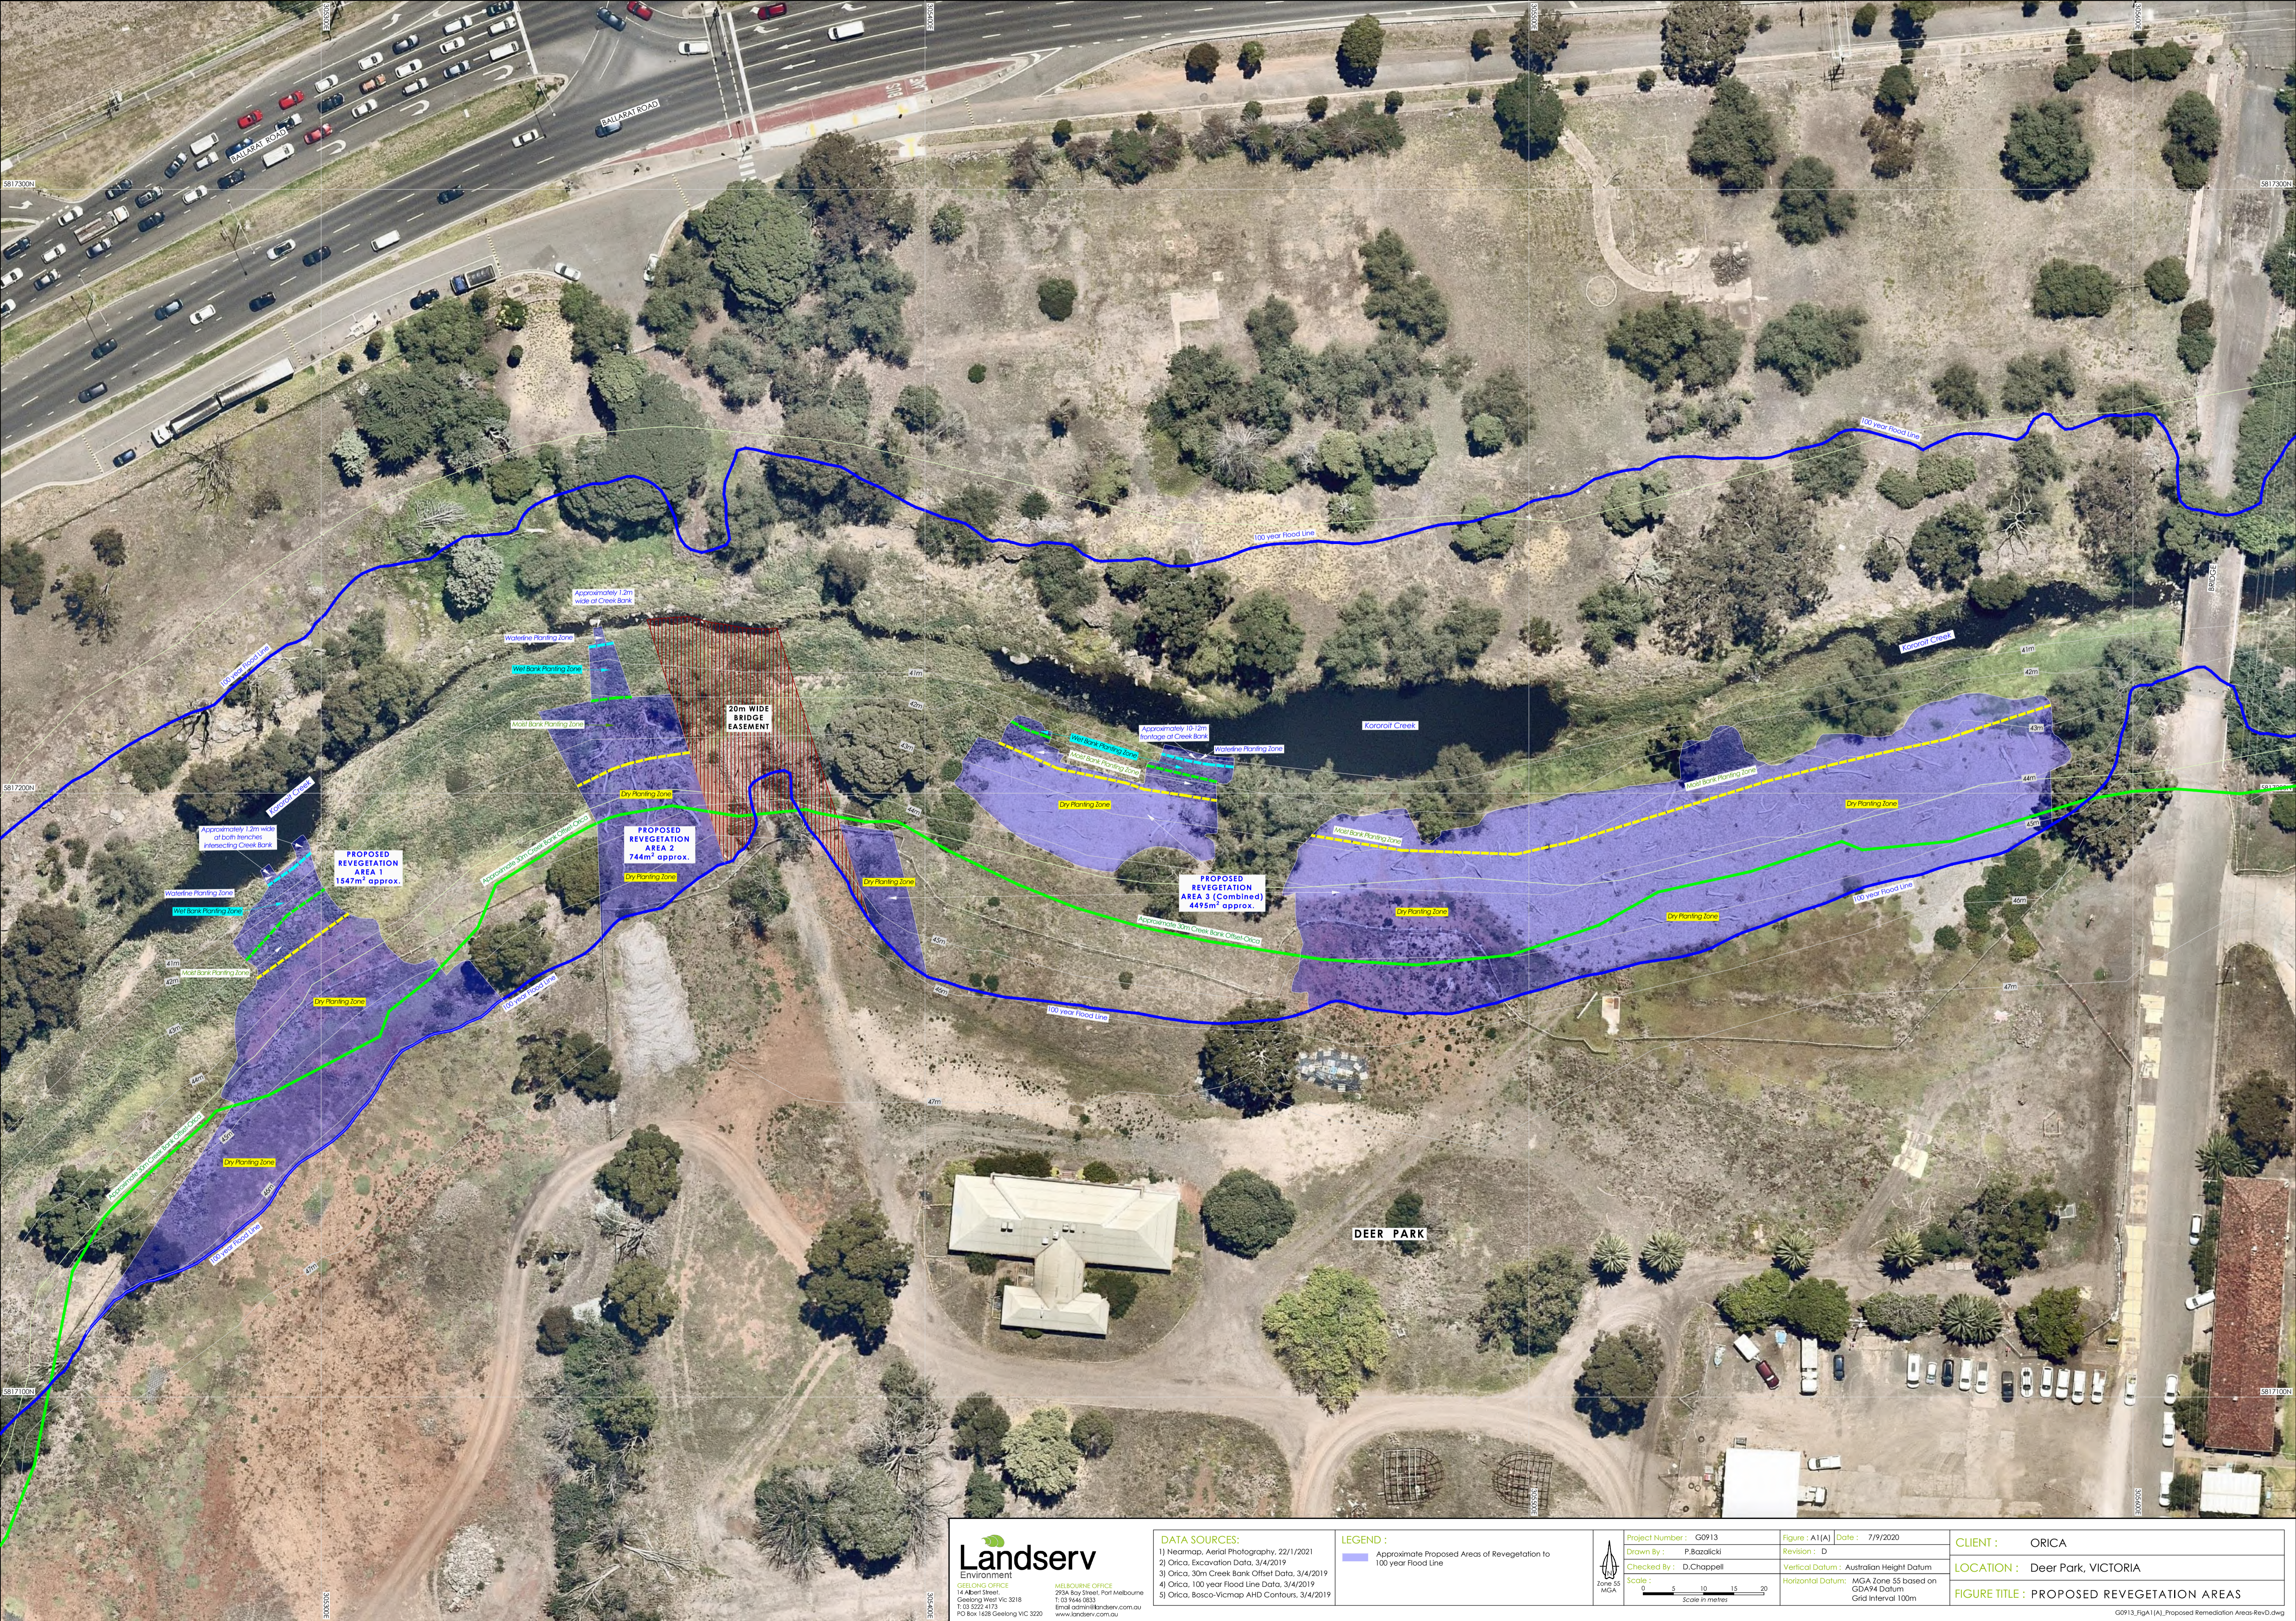
CLIENT: ORICA
LOCATION: Deer Park, VICTORIA
FIGURE TITLE: PROPOSED REVEGETATION AREAS

Figures A-1(A) and A-1(B) in **Appendix A** provides a plan view of the areas where excavation has been completed. The excavations have been backfilled with local basaltic rock and soil. As discussed with Gerard Morel (Waterways and Land Officer, Werribee Catchment, Melbourne Water) on 9 May 2021, mulch has been placed in most of Area 3 and 'coarse woody debris' (log and dead trees) have been placed in Areas 2 and 3. Aerial images are provided below (**Figures 3-1, 3-2, 3-3 and 3-4**), showing the state of backfilled excavations at various times on 'Nearmap' images.

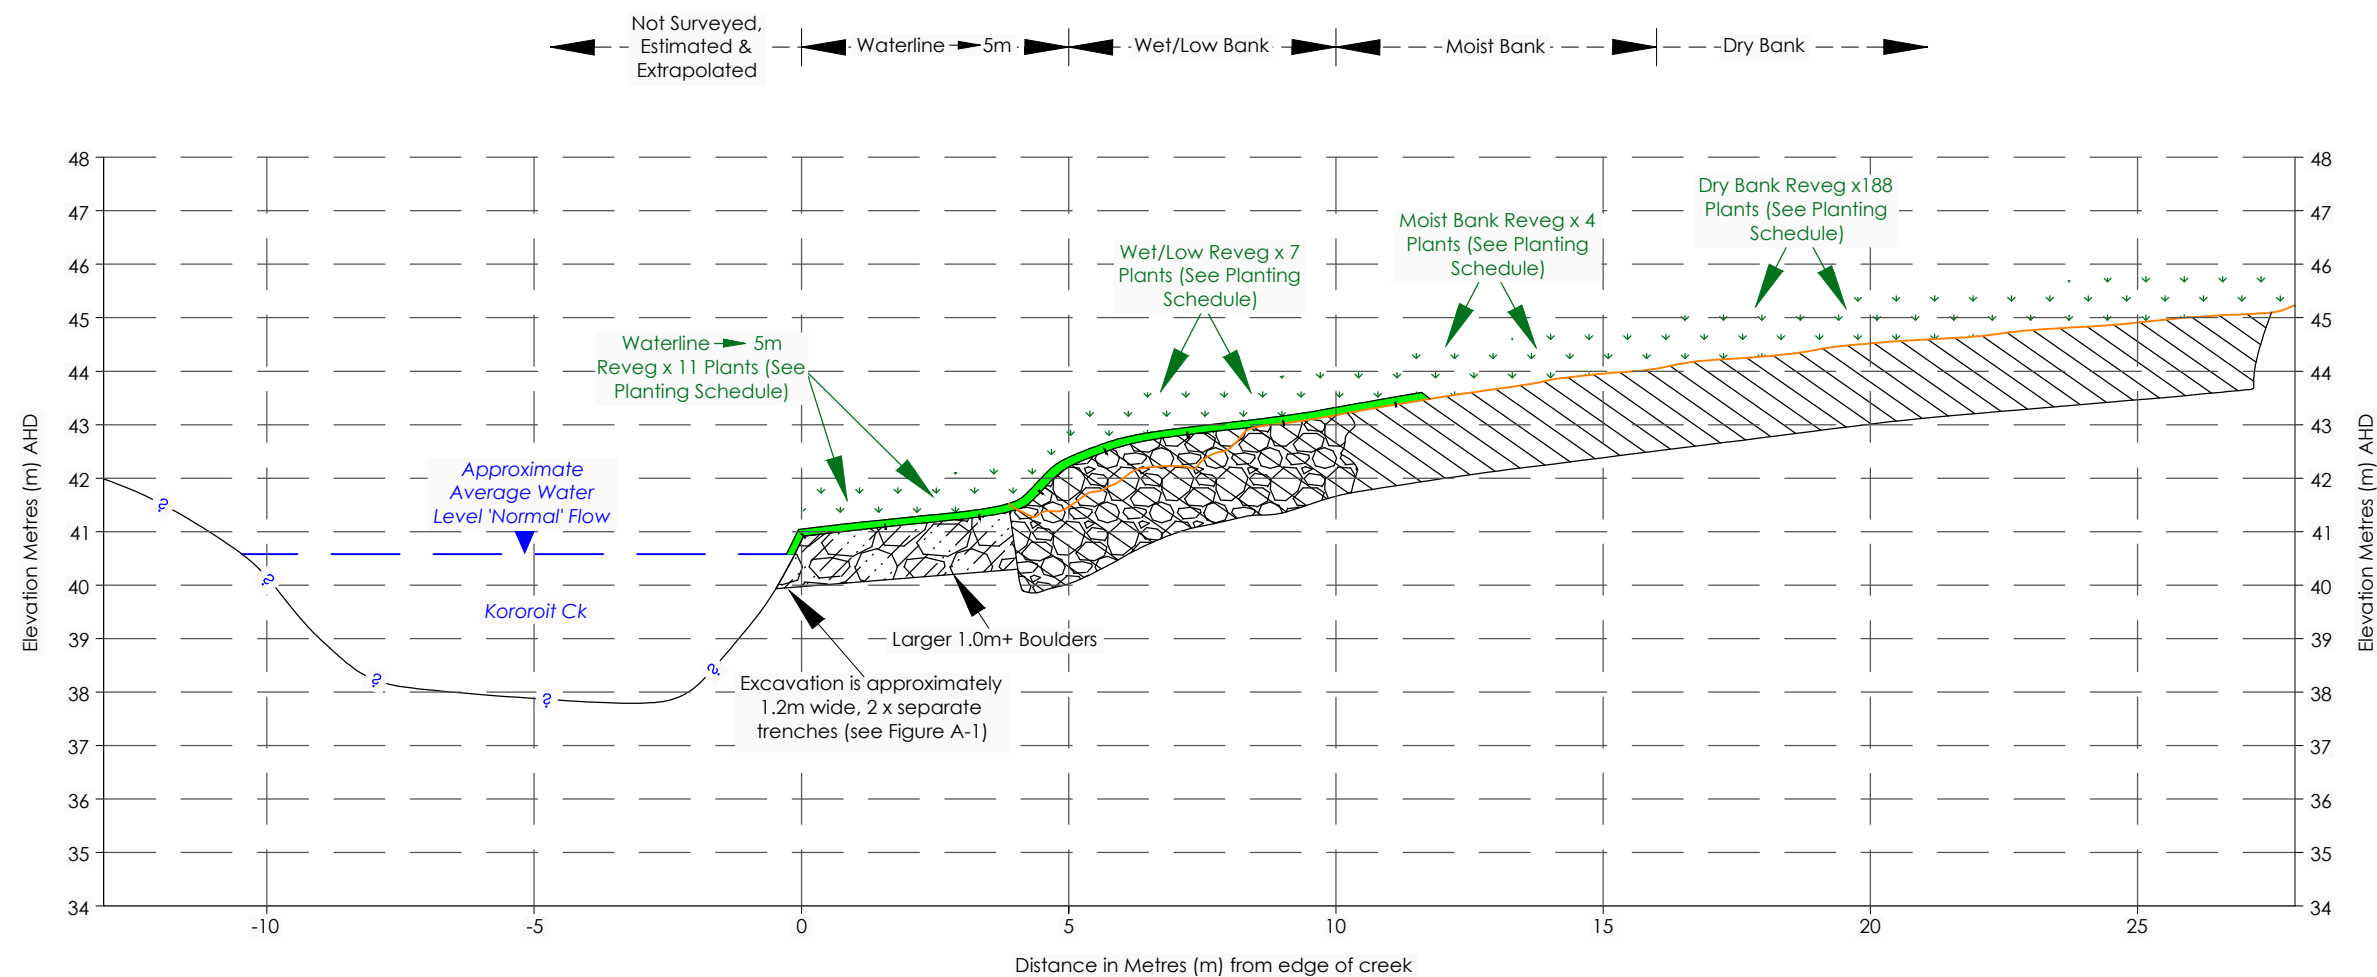
AREA 1 - CROSS SECTION OF BACKFILLING AND REVEGETATION

The cross-sections (**Figures A-2, A-3, A-4 and A-5 in Appendix A**) show the excavation completed to date. The excavations to date have generally extended 1.0 to 2.0 metres below ground level (bgl), which is not as deep as anticipated during the planning phase.

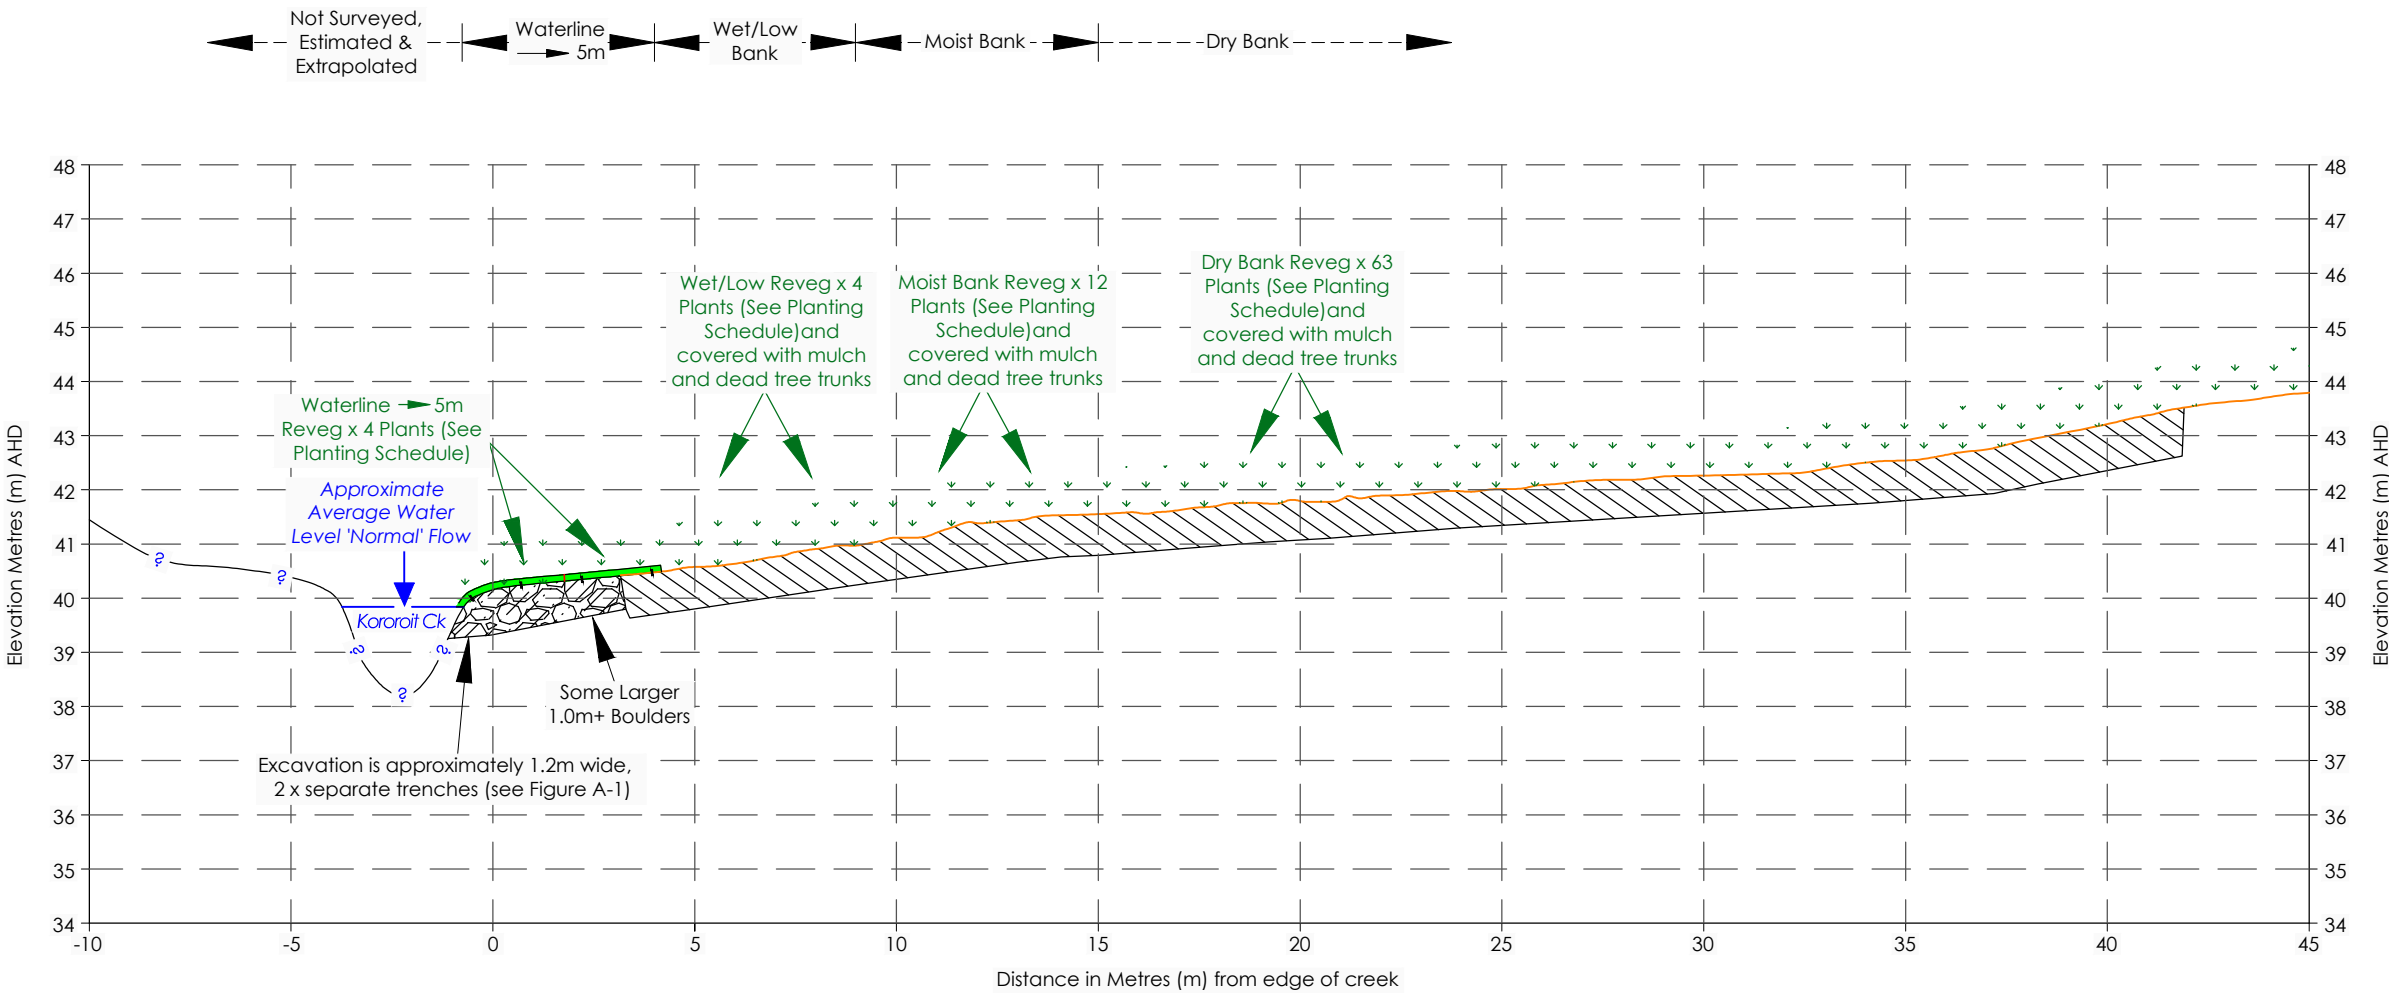
AREA 2 - CROSS SECTION OF BACKFILLING AND REVEGETATION

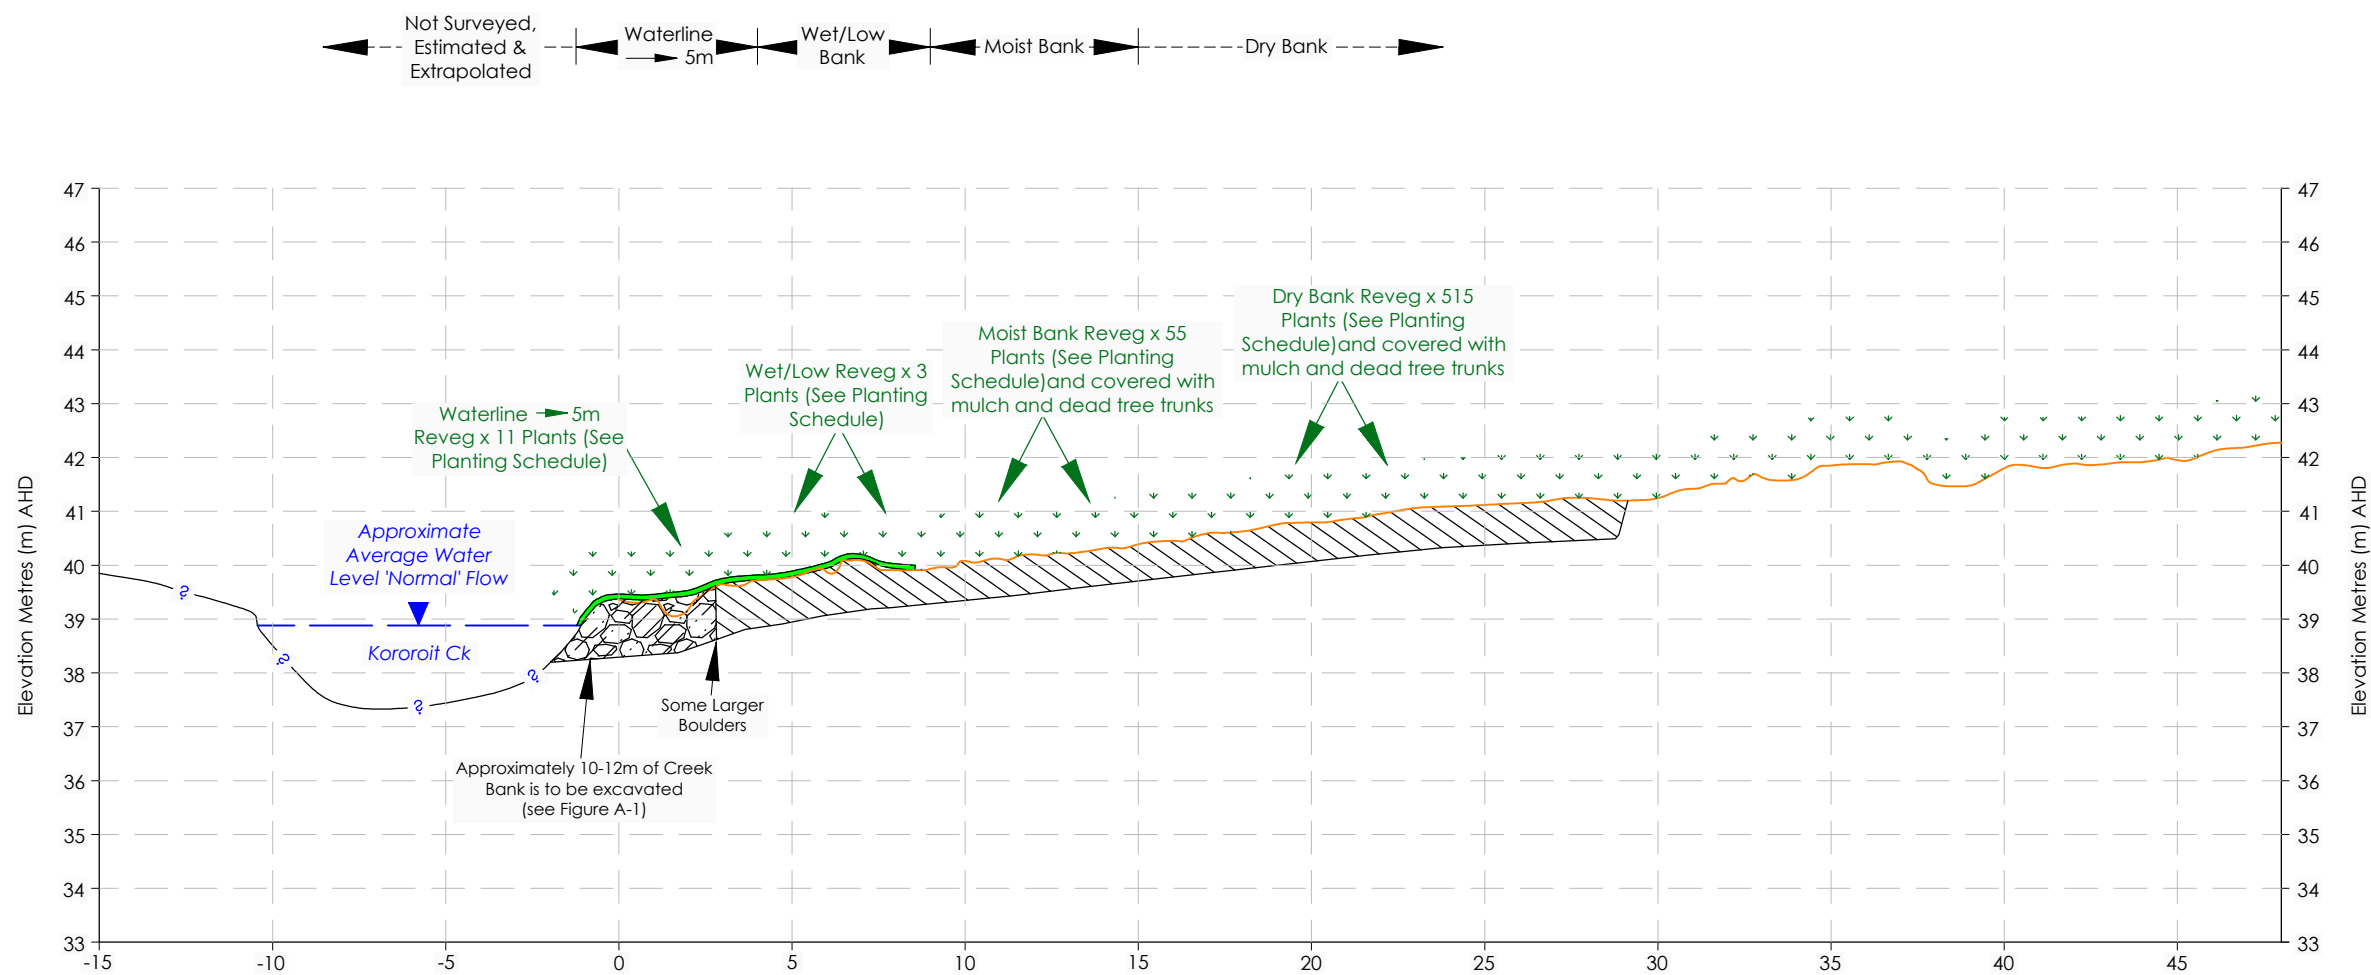
AREA 3 - CROSS SECTION OF BACKFILLING AND REVEGETATION

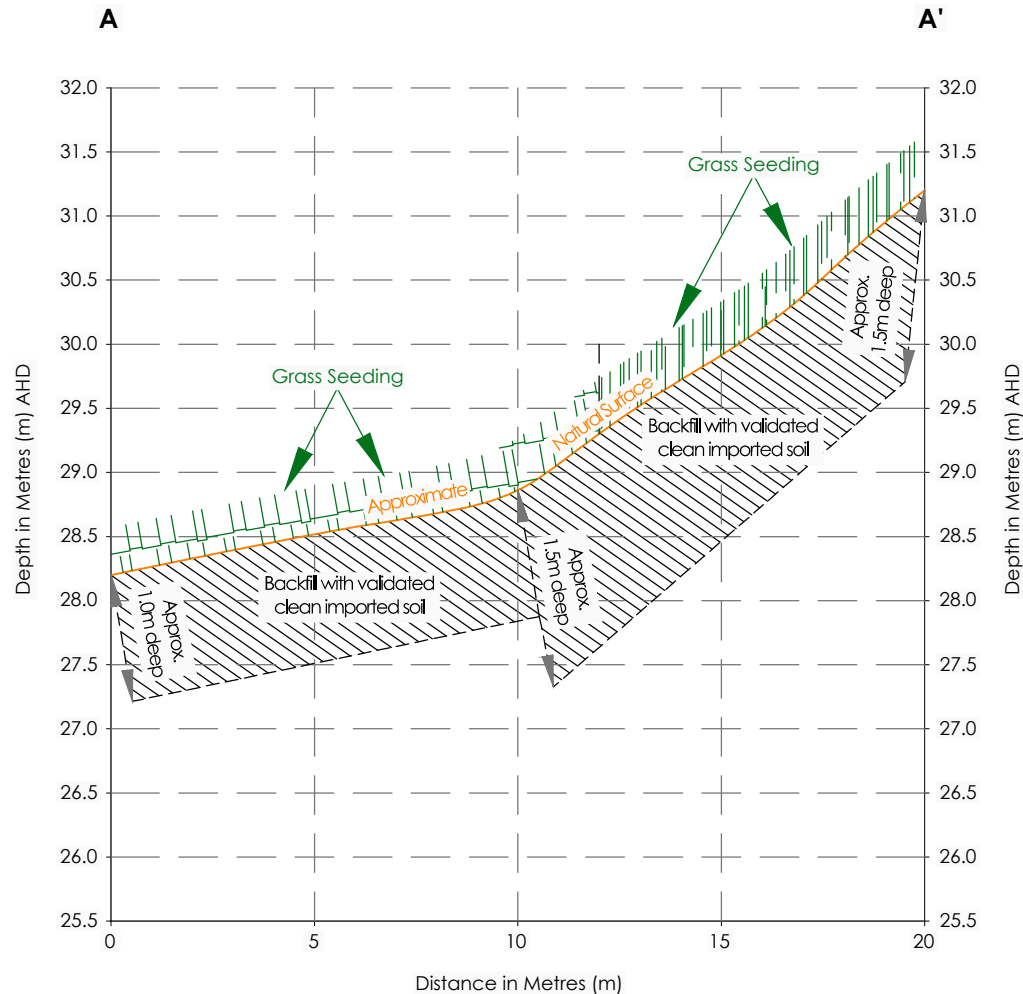
AREA 8 - CROSS SECTION OF BACKFILLING AND REVEGETATION
